# FULL RESERVE STUDY

## Lantana Ridge Property Owners Association

**Spring Branch, Texas**

**April 27, 2022**

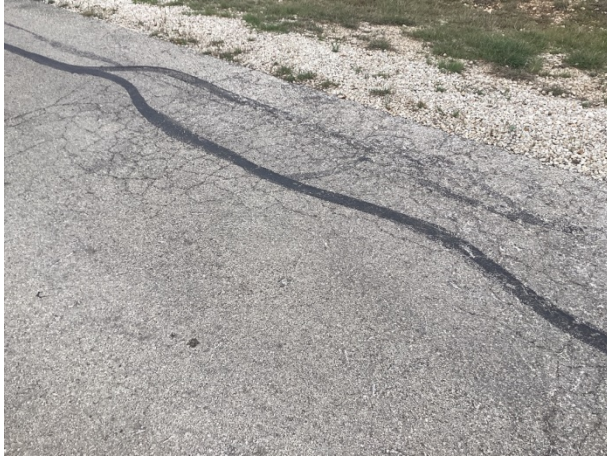
**Condition:** .The pavement varies from good to fair overall condition with cracks evident. The pavement at Lantana Valley is in fair to poor condition with frequent cracks and settlement evident.

**Alligator cracks**

**Component Detail Notes:** Proposals should include mechanically routing and filling all cracks with hot emulsion. Repairs should also include patching at areas exhibiting settlement, potholes, or excessive cracking. The contractor should only apply seal coat applications after repairs are completed. A seal coat does not bridge or close cracks, therefore, unrepaired cracks render the seal coat applications useless. These activities minimize the damaging effects of vehicle fluids, maintain a uniform and positive appearance, and maximize the useful life of the pavement.

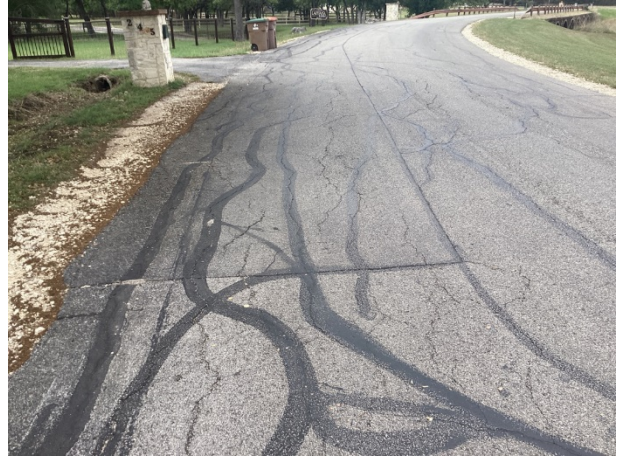
**Pavement cracks at Lantana Valley**

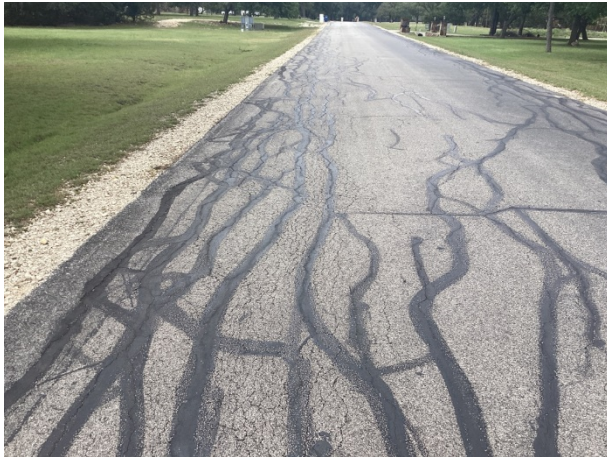
**Pavement cracks at Lantana Valley**

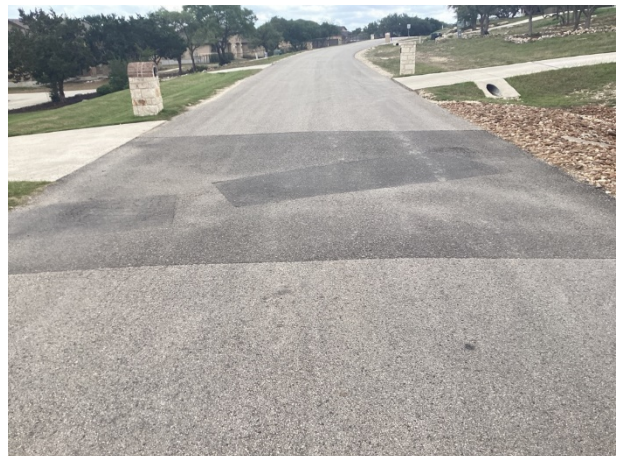
**Patch with alligator cracks at Lantana Crossing**

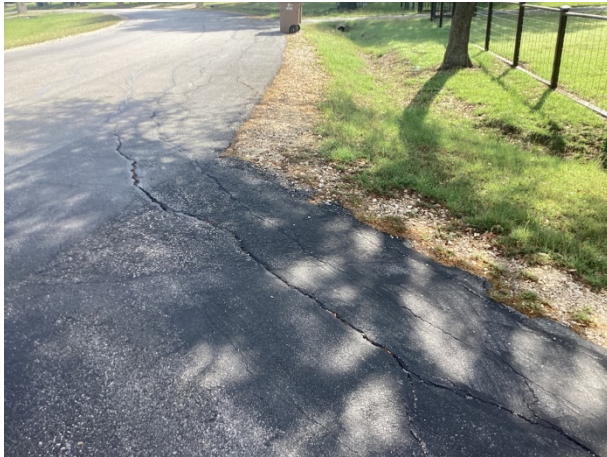
**Slippage cracks near park entrance**

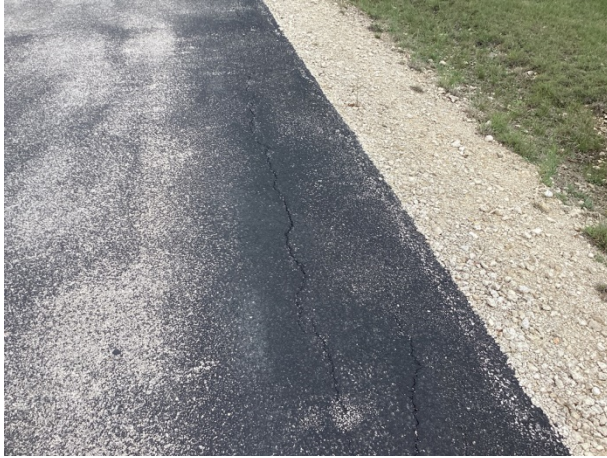
**Edge cracks**

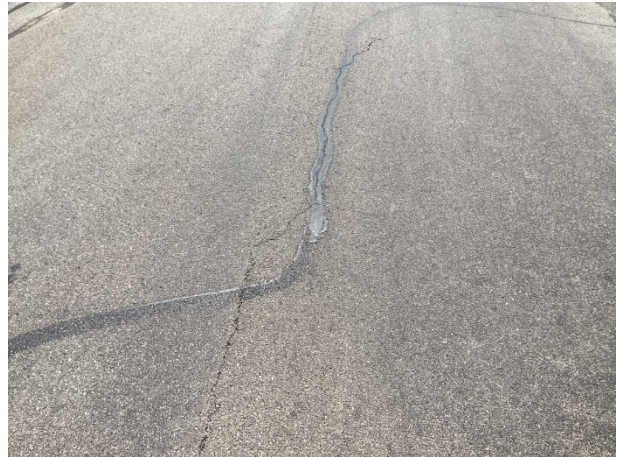
**Pavement cracks**

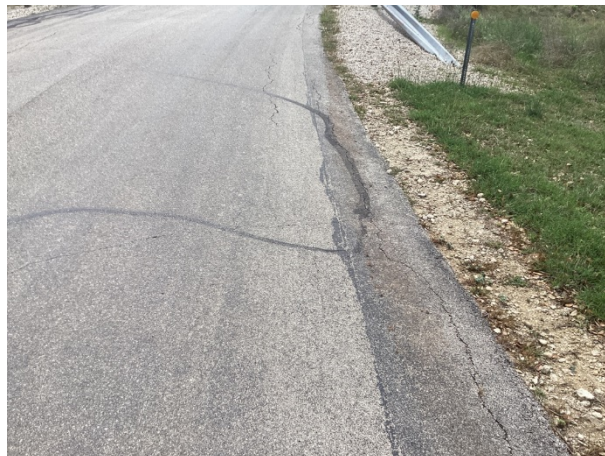
**Edge cracks**

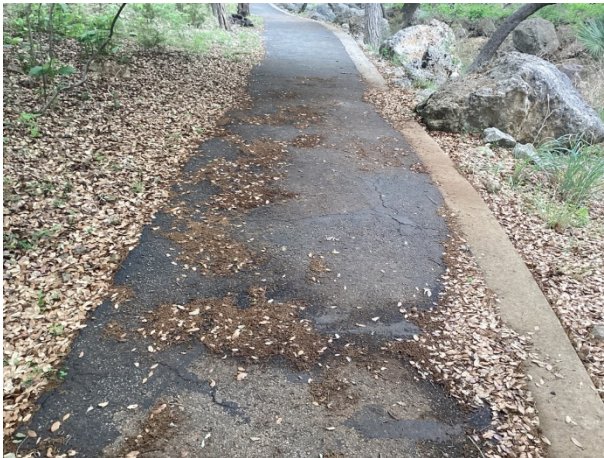
**Condition:** Fair overall with periodic cracks and settlement evident.

**Walking path cracks**

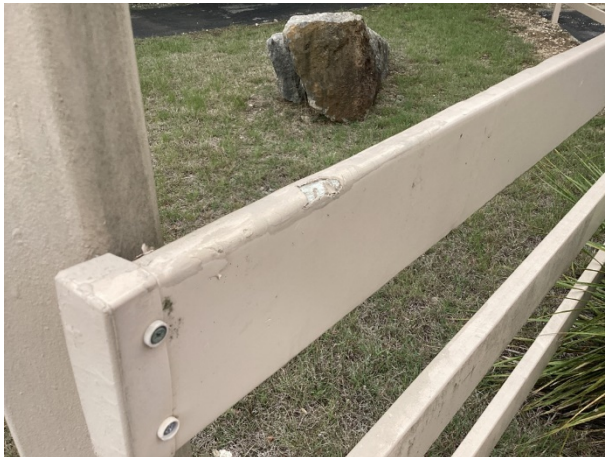
**Condition:** Fair overall condition

Vinyl wrap deterioration

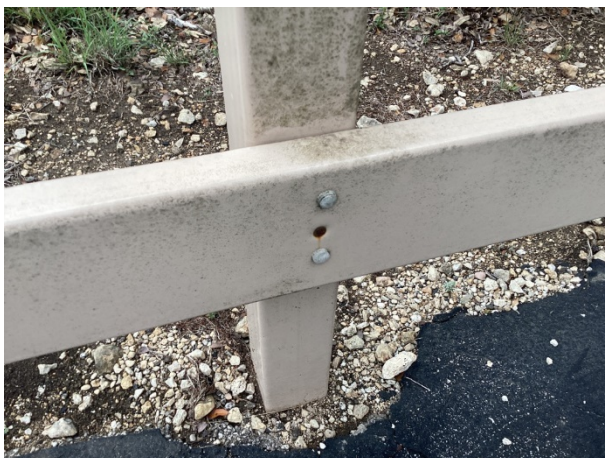
Fastener rust

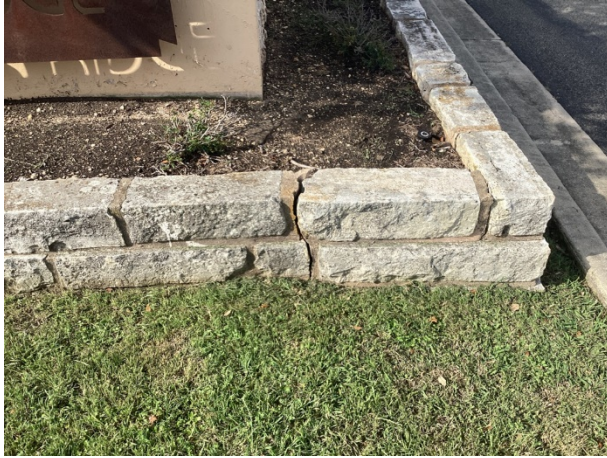
**Masonry cracks**

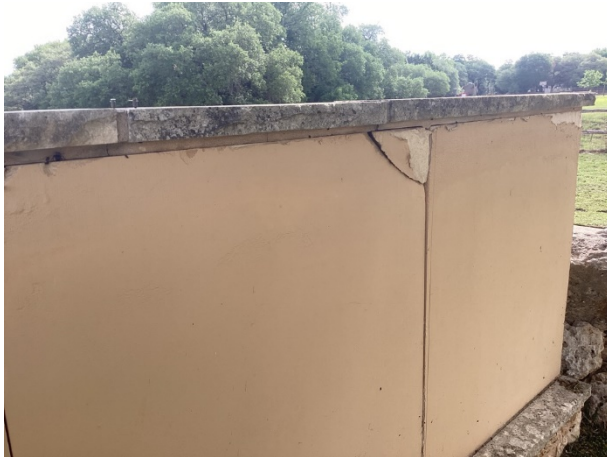
**Concrete cracks**

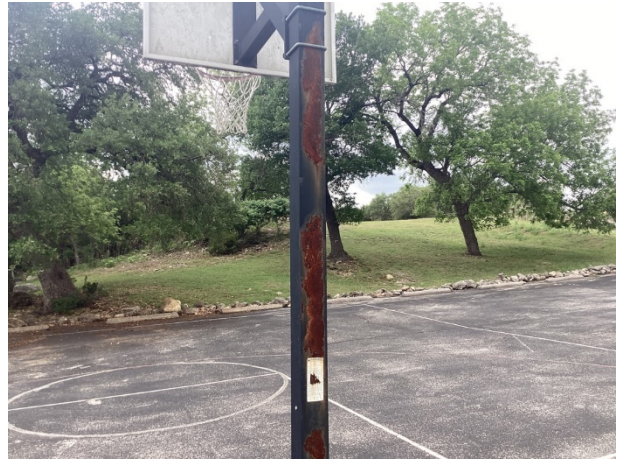
Finish deterioration and rust

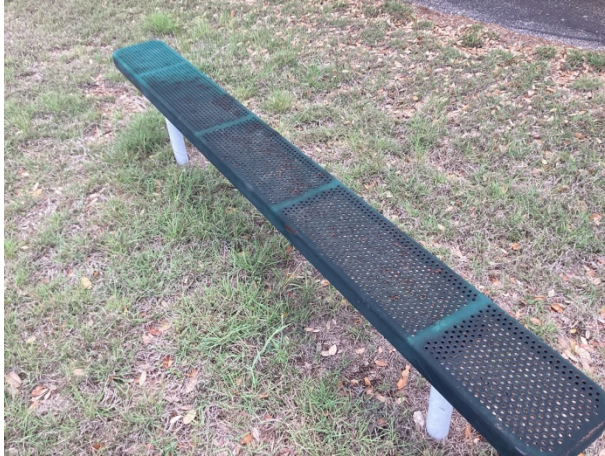
**Furniture rust**
