# FULL RESERVE STUDY

## Lantana Ridge Property Owners Association

**Spring Branch, Texas**

**April 27, 2022**

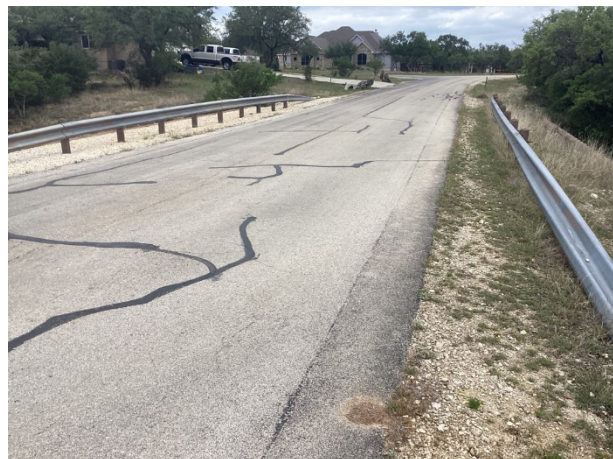
Asphalt pavement street overview

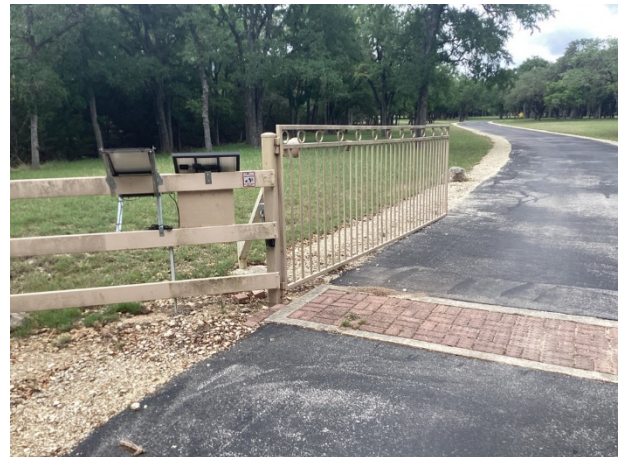
**Steel gate at park**

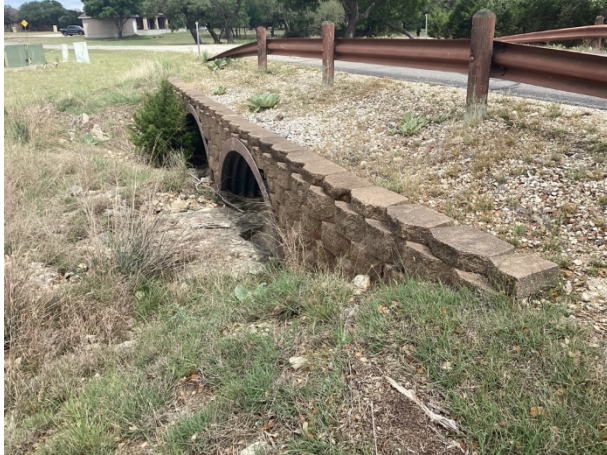
**Condition:** Good overall with no significant deterioration evident

**Retaining wall at bridge 3**

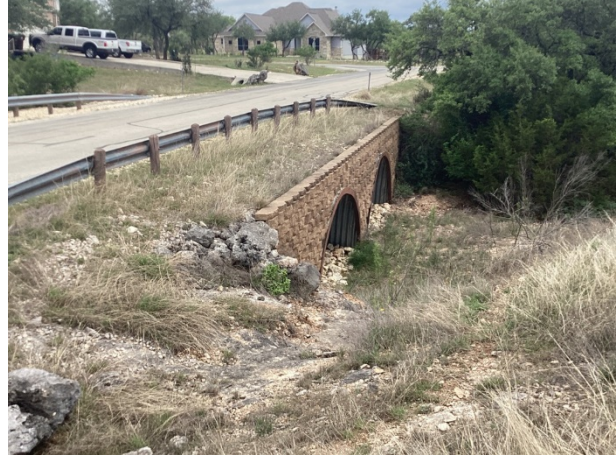
**Retaining wall at bridge 5**

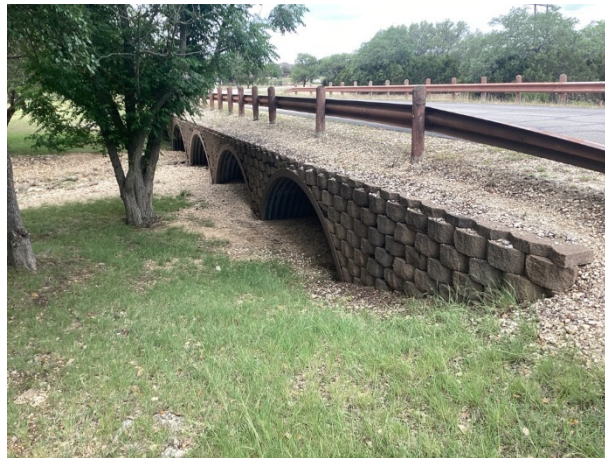
**Masonry retaining wall at bridge 2**

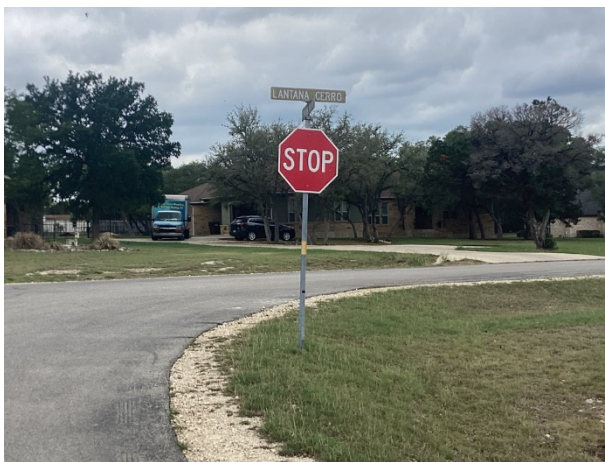
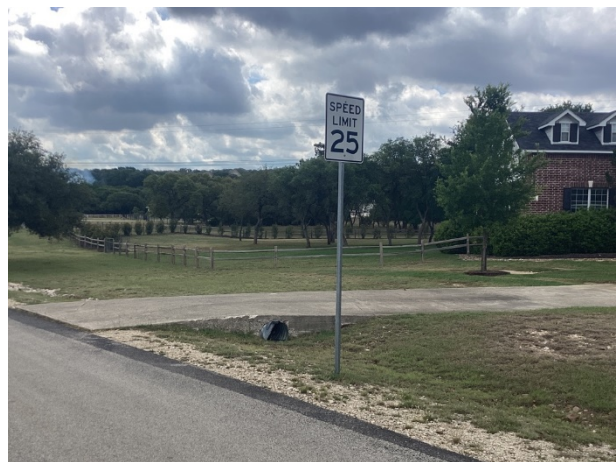
**Condition:** Good to fair overall

Traffic management signage
