# FULL RESERVE STUDY

## Lantana Ridge Property Owners Association

**Spring Branch, Texas**

**April 27, 2022**

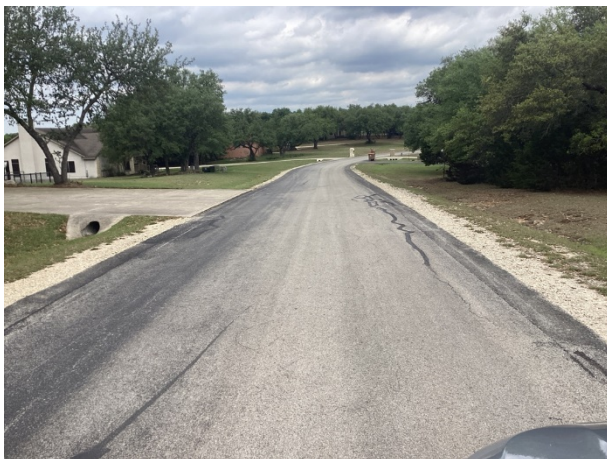
**Condition:** .The pavement varies from good to fair overall condition with cracks evident. The pavement at Lantana Valley is in fair to poor condition with frequent cracks and settlement evident.

Lantana Ridge overview

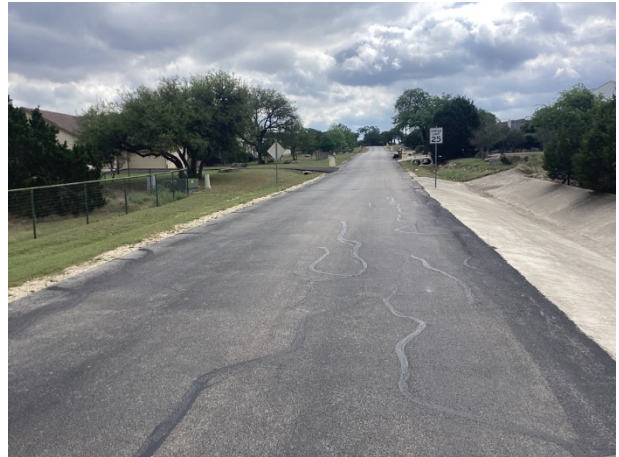
**Lantana View overview**

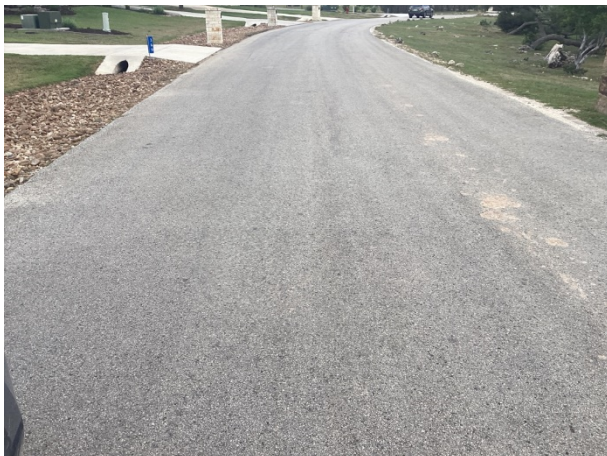
**Lantana Crossing overview**

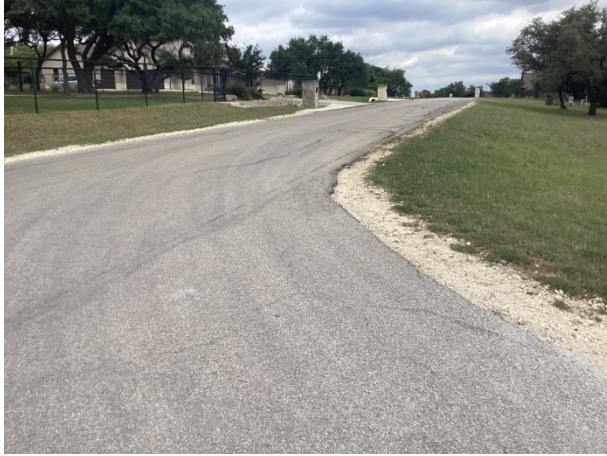
**Loma Doble overview**

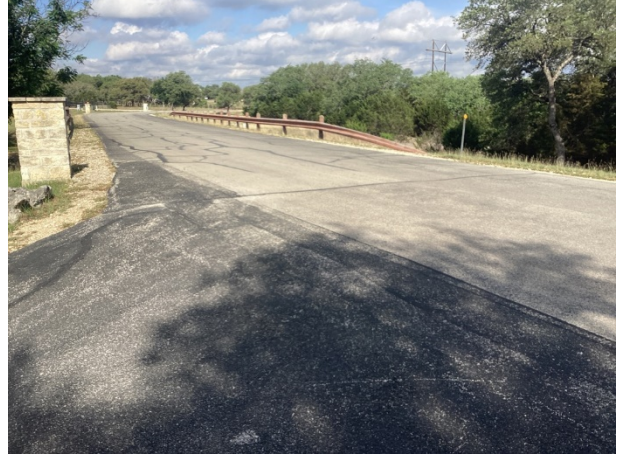
**Lantana Valley overview**

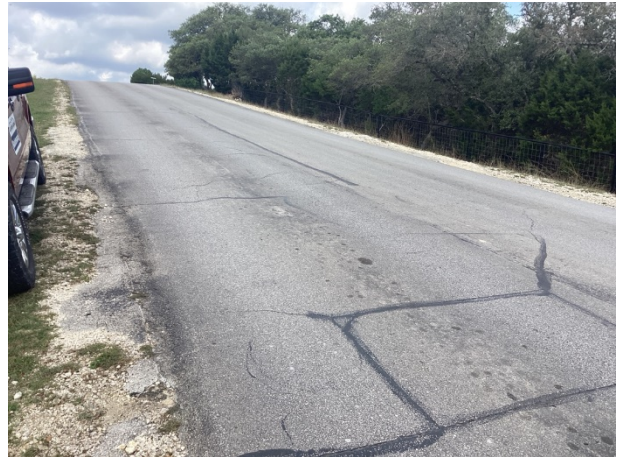
**Lantana Mesa overview**

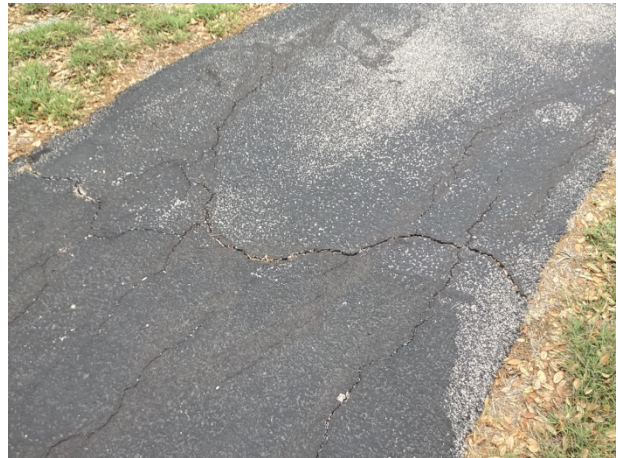
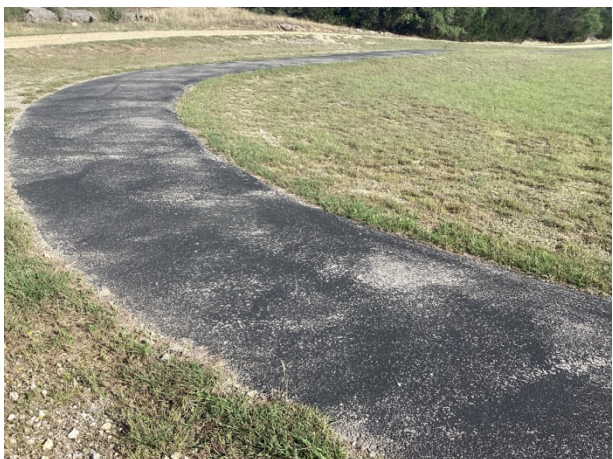
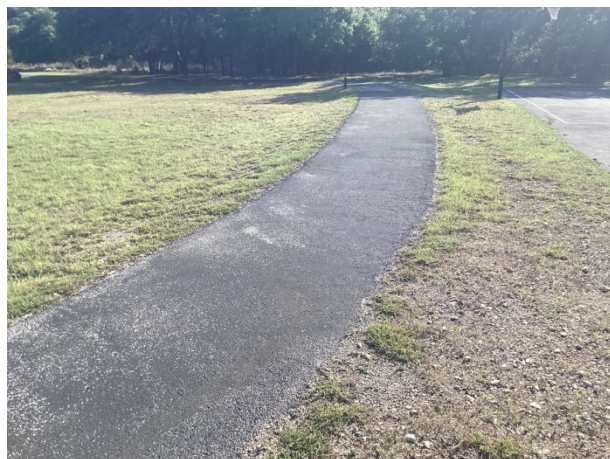
**Asphalt pavement walking path**

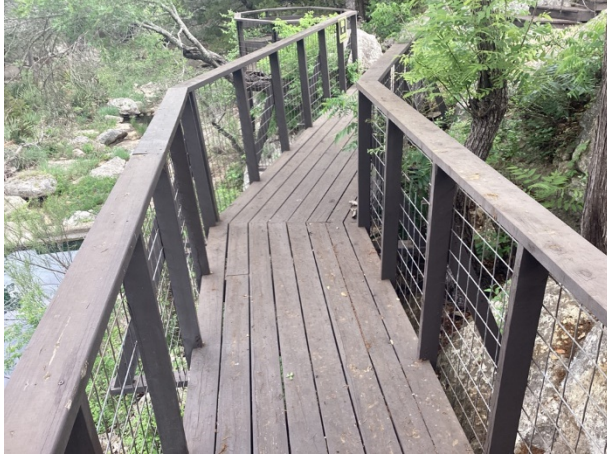
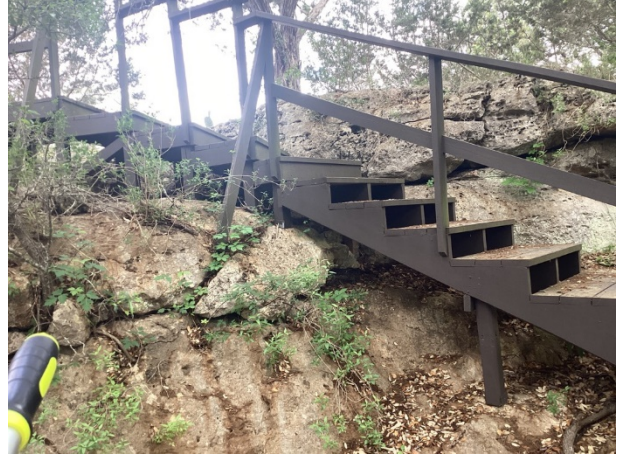
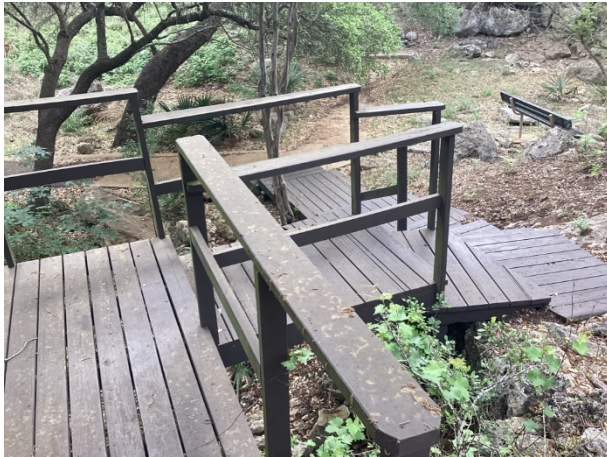
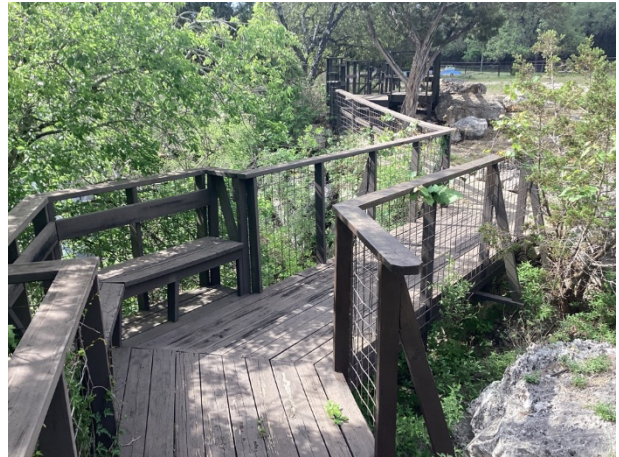
**Condition:** Good overall condition with no significant deterioration evident

**Boardwalk overview**

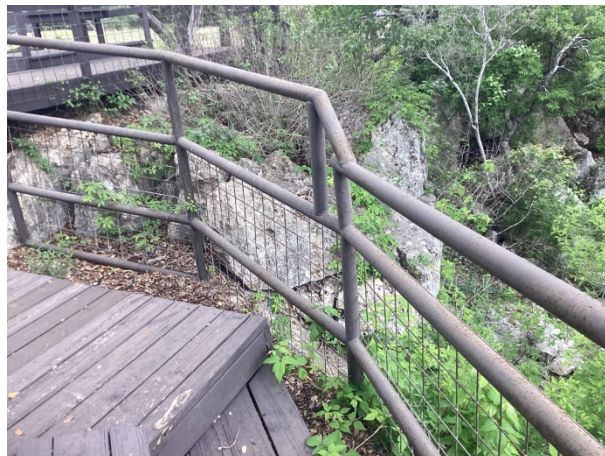
**Metal railing**

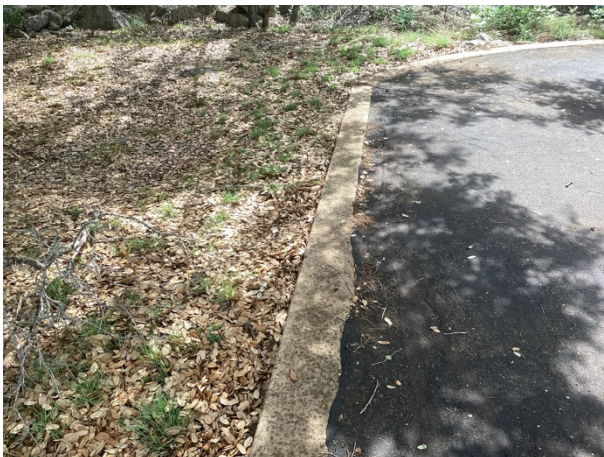
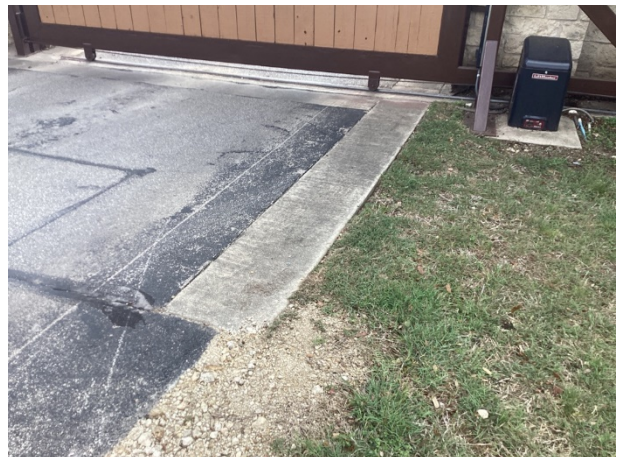
**History:** Good overall condition

Concrete curb

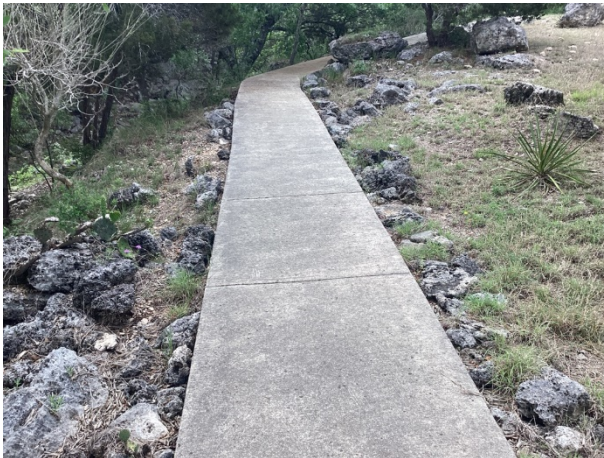
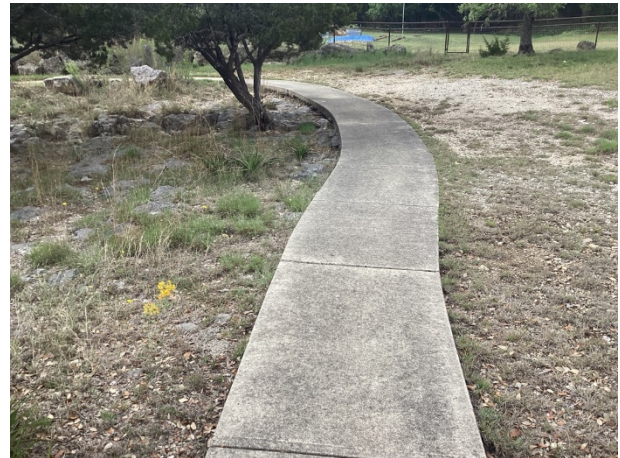
**Condition:** Good overall

Concrete sidewalk

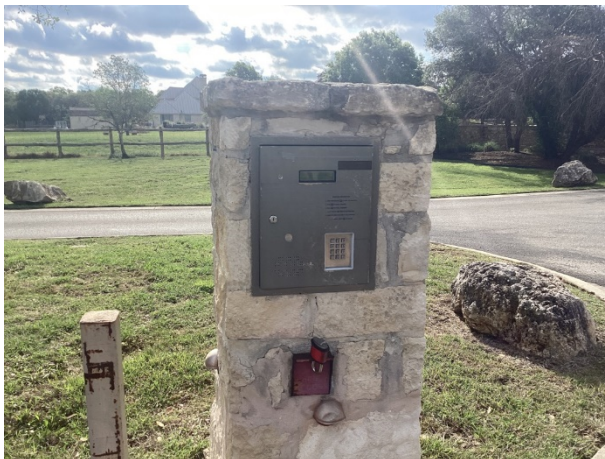
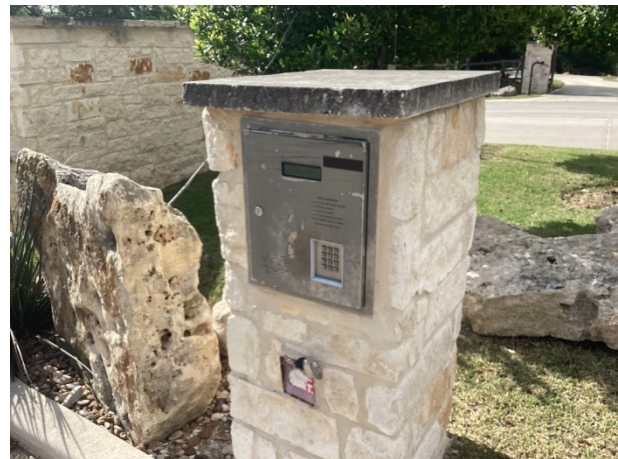
**Condition:** Reported in good to fair overall condition

Gate entry callbox

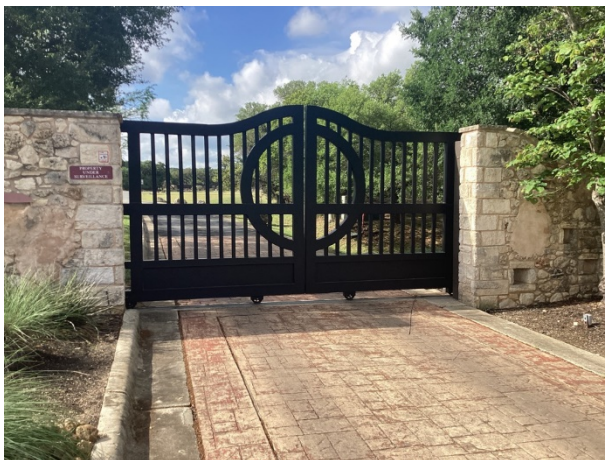
- Gates: Good overall condition
- Operators: Reported in satisfactory overall condition

**Steel gates at Lantana Valley**

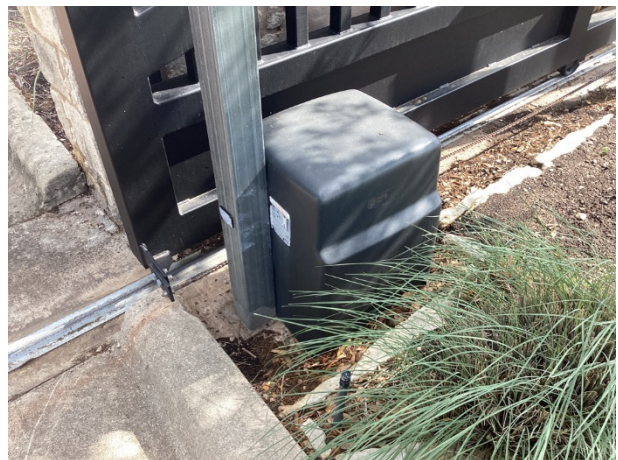
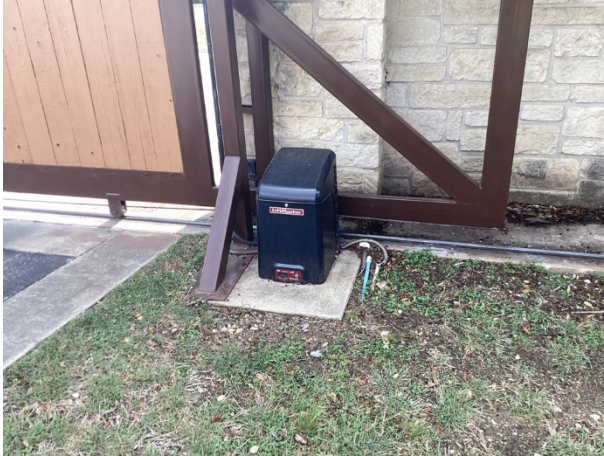
**Gate operator**

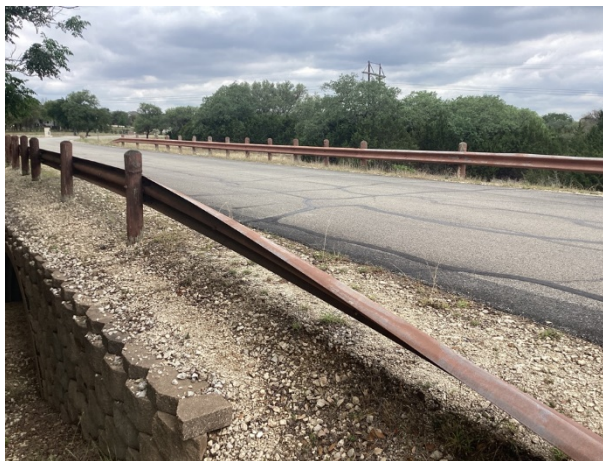
**Condition:** Good

**Guard rails**

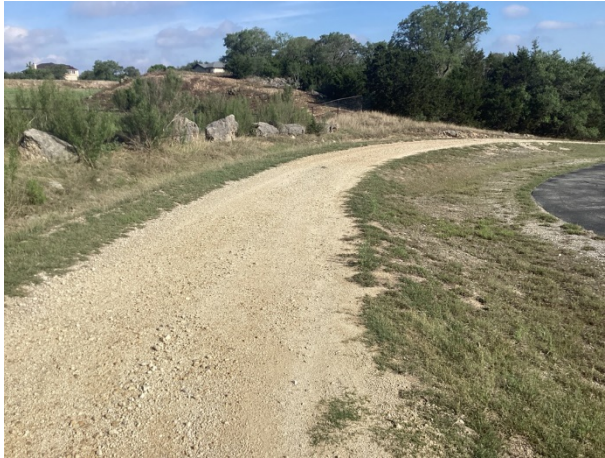
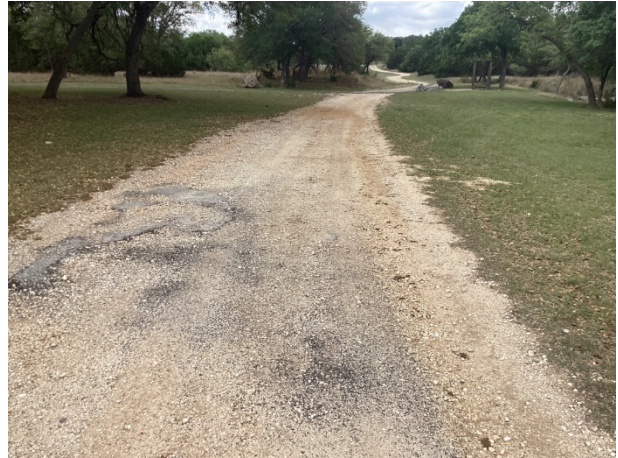
**Condition:** Good to fair overall

Gravel road overview

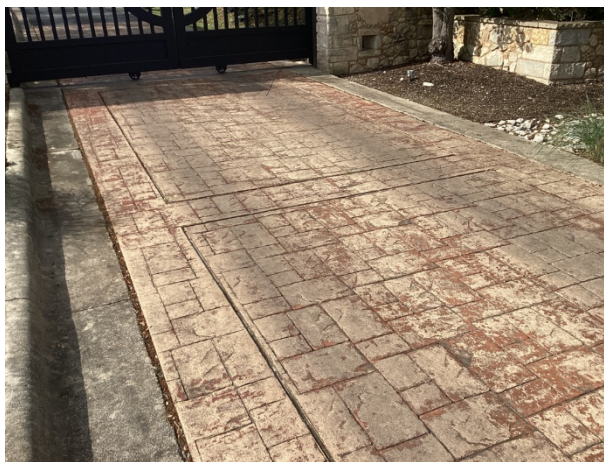
**Condition:** Good overall with no significant deterioration evident

**Stamped concrete pavers**

**Expenditure Detail Notes:** Expenditure timing and costs are depicted in the **Reserve Expenditures** table in Section 3. We recommend the Association apply stain finishes as needed to and fund these activities through the operating budget.

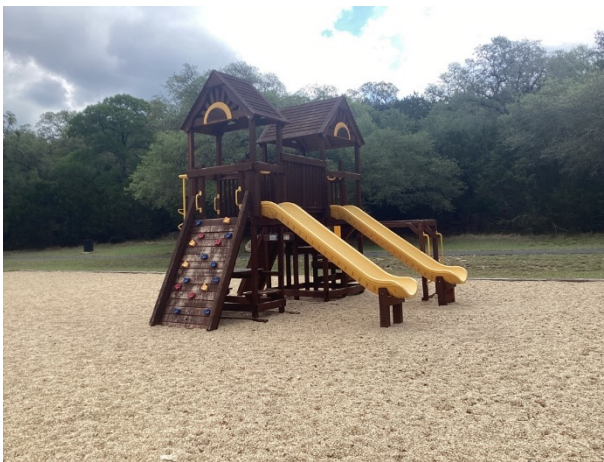
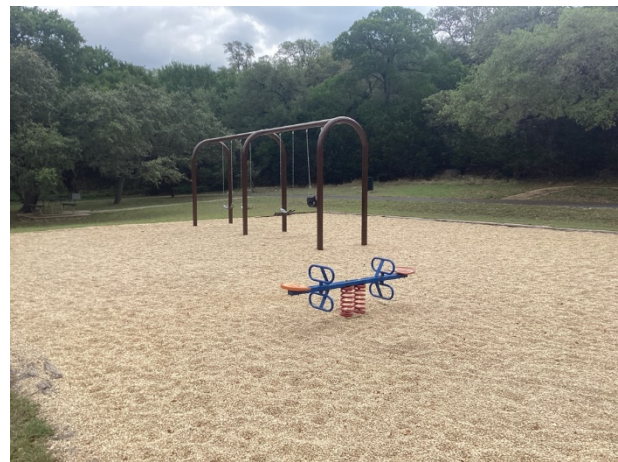
**Condition:** Good overall

Playground equipment

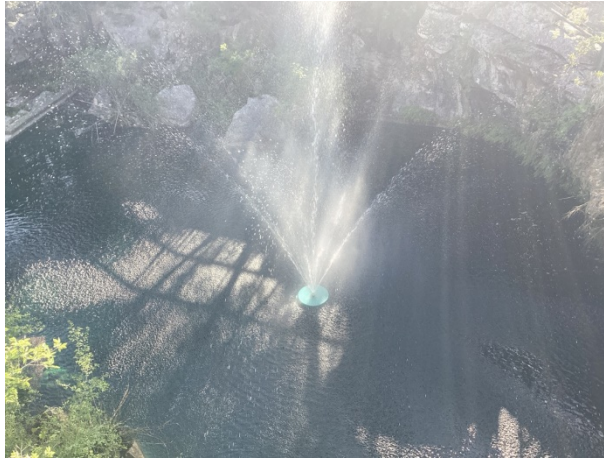
**Condition:** Reported satisfactory without operational deficiencies

**Pond aerator**

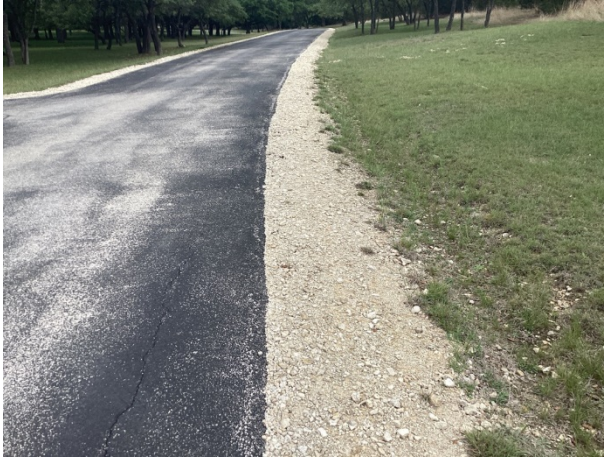
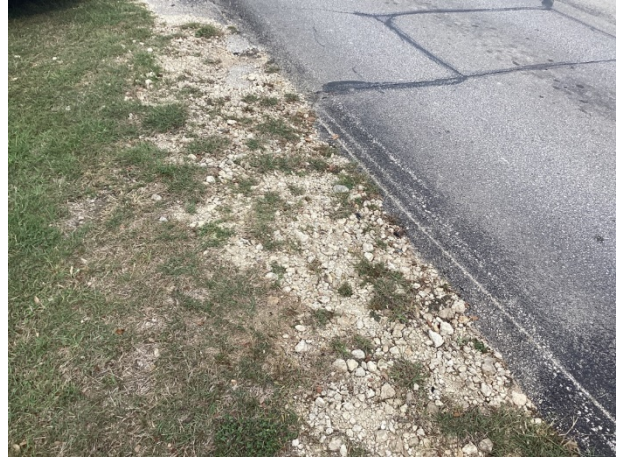
**Condition:** Good overall condition

Gravel shoulder

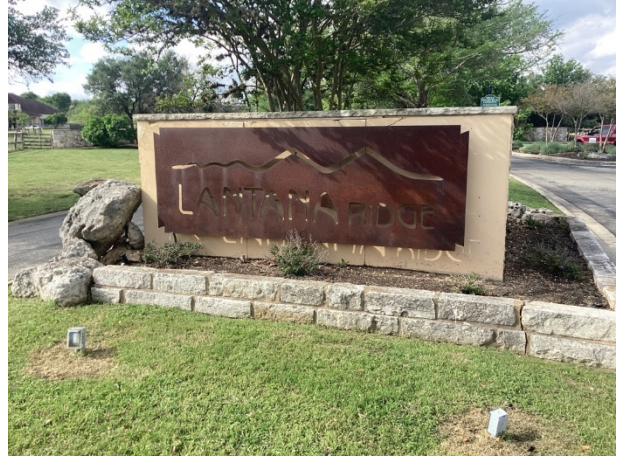
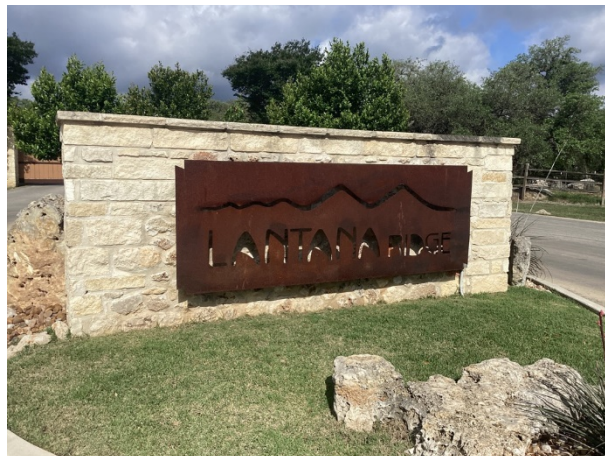
**Entrance monument**

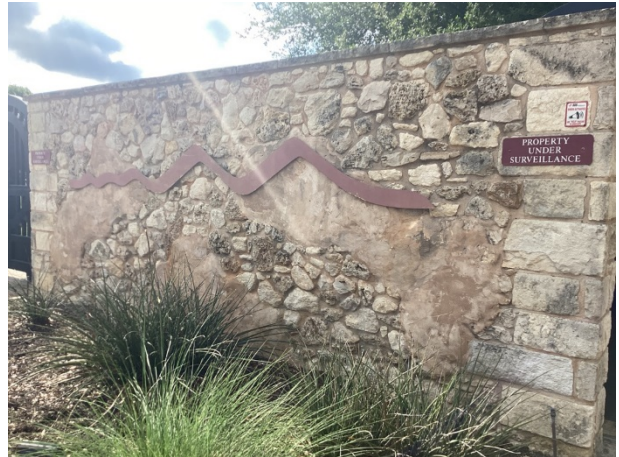
**Entry monument wall**

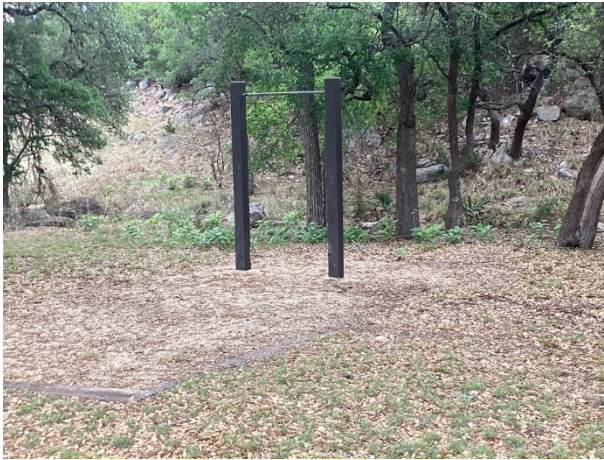
**Condition:** Good overall

Exercise equipment

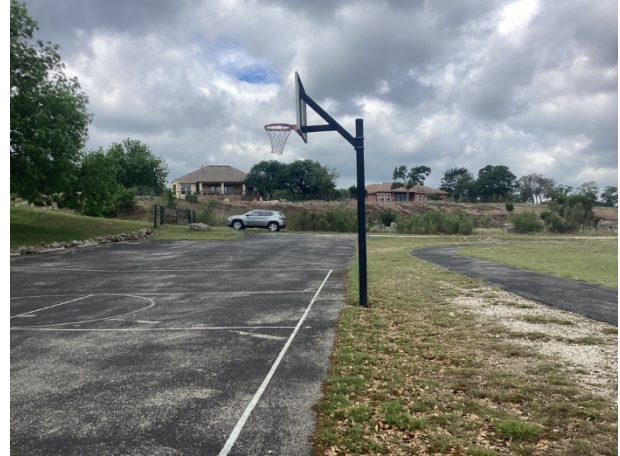
**Basketball goal**

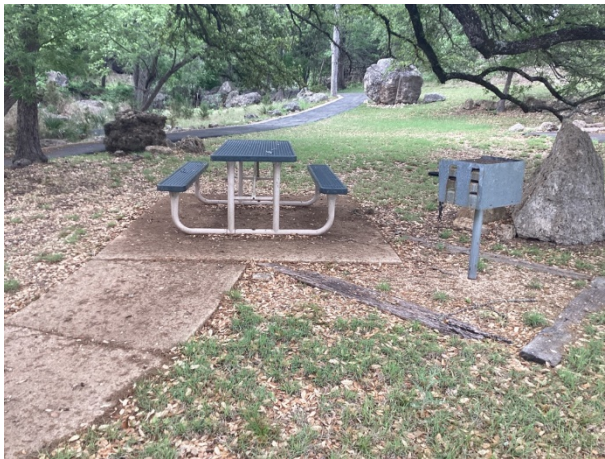
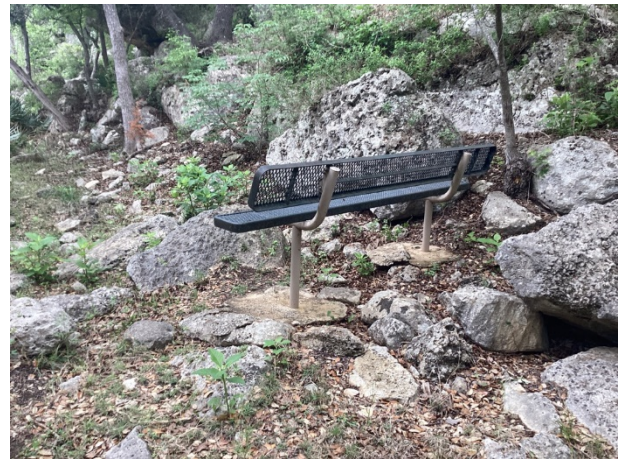
**Site furniture**

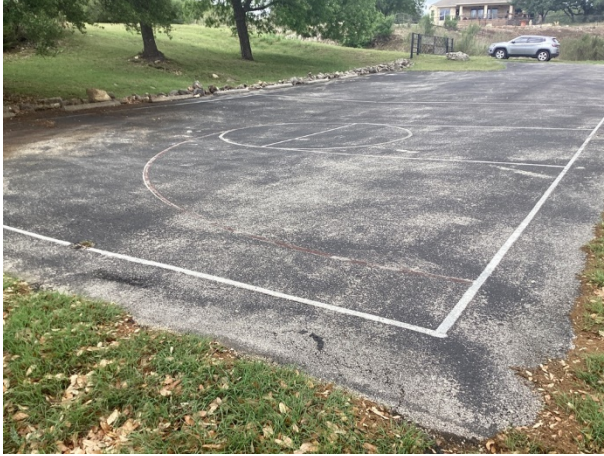
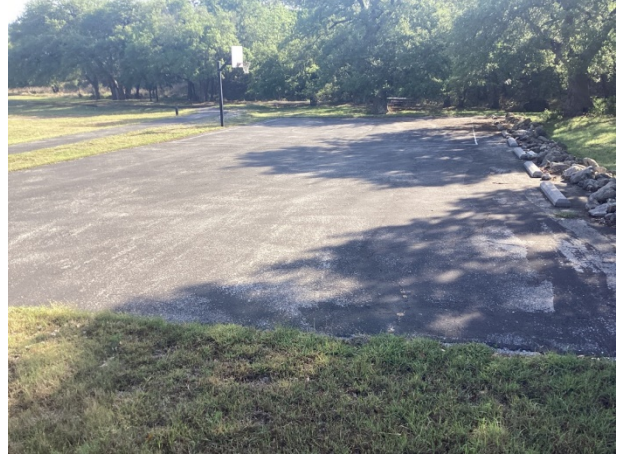
**Condition:** Good to fair overall condition

**Basketball court overview**

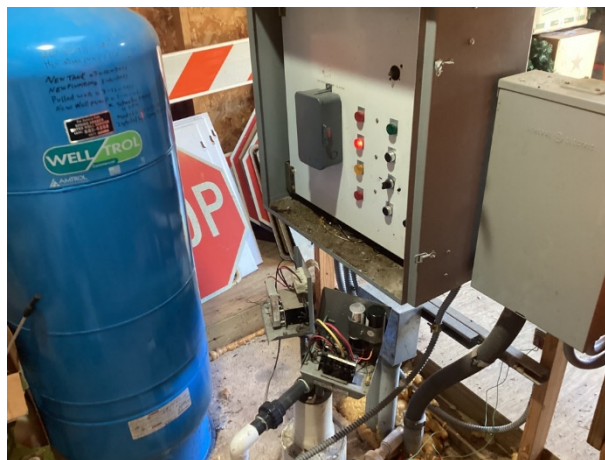
**Condition:** Good

**Well controls**
